# TAILINGS MANAGEMENT AT HECLA

## Tailings Stewardship Program

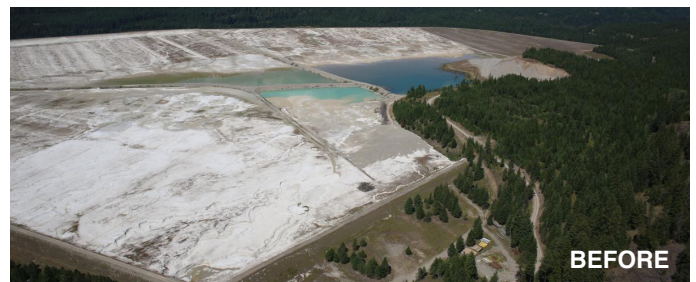
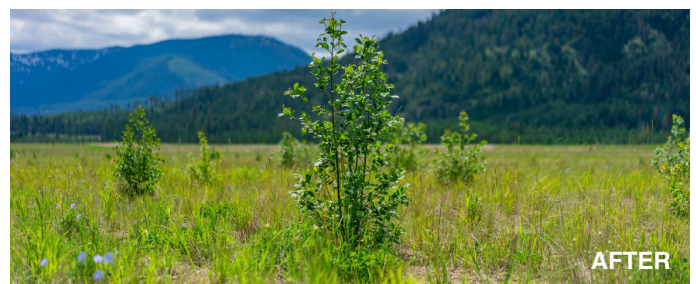
TROY RECLAMATION

**A.** Before we begin, we think of the finish. The initial tailings design process includes planning for final reclamation and closure of our tailings facilities. However, we perform concurrent reclamation where feasible. For example, we have closed two older facilities and are in the process of closing a third facility at the Lucky Friday Mine in Idaho. Also, the tailings facility at Grouse Creek in Idaho is no longer considered a jurisdictional dam, has been reclaimed, and the financial assurances released. At the Troy Mine in Montana, we have reclaimed the 300-acre tailings storage facility by placing soil cover and revegetating the surface to return the land to productive post-mining uses. We have planted more than 200,000 shrubs and trees that are already creating a self-sustaining native forest community and wildlife habitat.
